ARE YOUR SILO ROOFS FAILING?

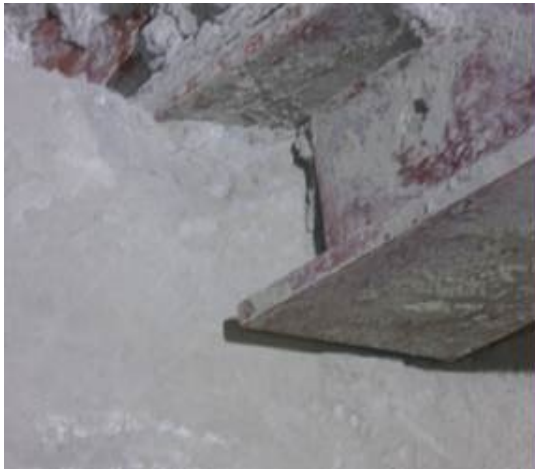
Aging silos often show signs of deterioration, usually visible in the spalling and cracking of the exterior of silo walls. This is due mostly from exposure to the weather. Problems with silo roof slabs are mostly related to critical structural conditions, such as dust buildup, the addition of heavy equipment to the original design, or flaws with the original design.

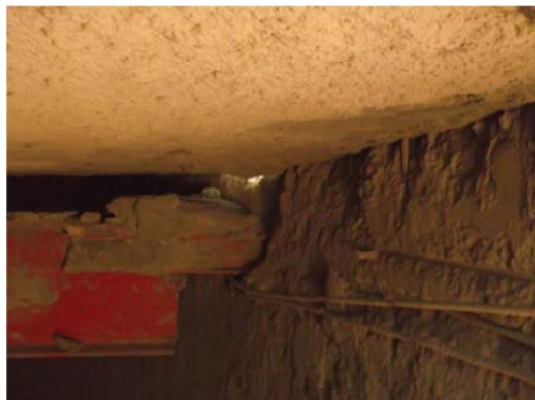
The embedded plates that support the roof beams are usually involved in the failure process. Weather and temperature changes cause the concrete walls to deteriorate faster around the beam pockets than the rest of the silo walls. Such deterioration leads to spalling and loosening of the bond between the emended steel anchors and the concrete walls. When

such conditions occur, the roof supporting steel beam will eventually rest on unprotected concrete. The constant thermal movement of the beam, combined with the dead and live loads applied on it, results in a grinding force between the beam's base plate and the silo wall with the eventual result of breakage of a part of the silo wall immediately under the beam. When this happens, the beam shifts downward until it rests again on a solid portion of the silo wall. The roof slab then deflects at which time the failure is usually noticed by the operators.
